## **Changes of fluvial processes caused by restoration of an incised mountain stream**

Bartłomiej Wyżga<sup>1</sup>, Maciej Liro<sup>1</sup>, Paweł Mikuś<sup>1</sup>, Józef Jeleński<sup>2</sup>,  
Artur Radecki-Pawlik<sup>3</sup>, Karol Plesiński<sup>4</sup>

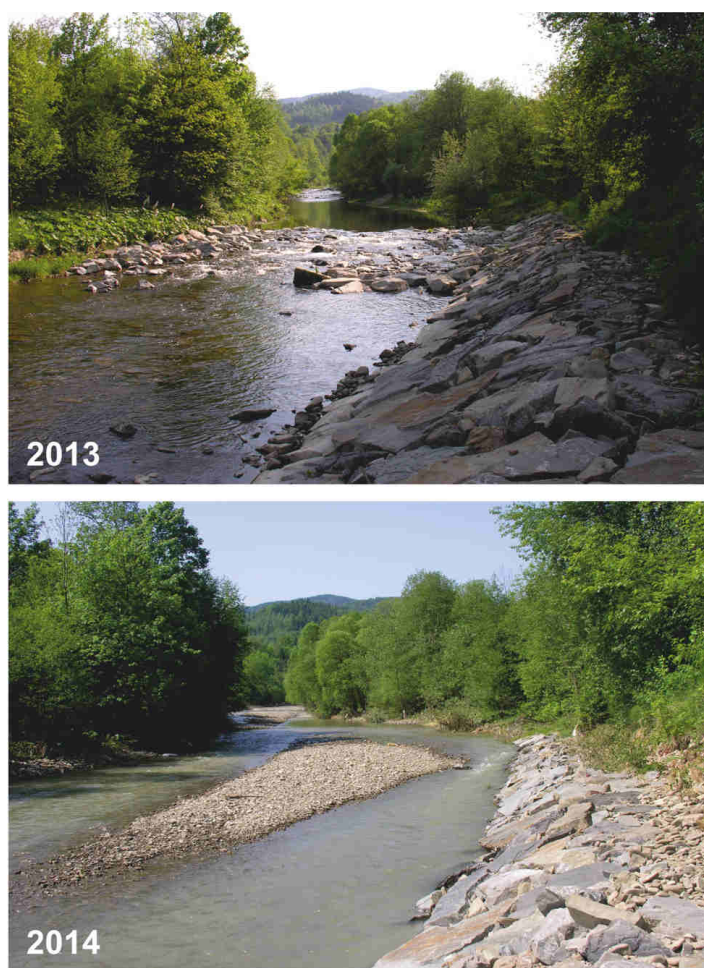
Deposition of the sediment flushed out from above the lowered check dam caused burying of the boulder ramps on the distance of ca. 1.2 km from the dam (Fig. 1), whereas the sediment wave reached 1.6 km from the dam. About 17000 m<sup>3</sup> of bed material were retained in the stream, resulting in re-establishment of alluvial channel bed and an average increase in bed elevation amounting to 0.44 m. A maximum increase in bed elevation in the surveyed cross-sections equalled 0.8 m at a distance of 470 m from the dam, whereas a maximum increase of the water surface at low flows reached 1 m. Bed aggradation increased peak flood stages, hence increasing a proportion of flood flows conveyed over the floodplain and reducing mean flow velocity and mean bed shear stress in the total cross-section and in the channel zone. While these effects varied along the channel, at the mid-length of the sediment accumulation formed downstream of the dam, peak stage of a 2-year flood increased by 0.7 m, while that of a 50-year discharge by 0.37 m. At this location, mean flow velocity decreased by 9% at a 2-year flood and by 16% at a 50-year discharge, whereas mean bed shear stress was reduced by 39% and 46%, respectively. Increased inundation of the floodplain was reflected in increased retention potential of floodwater, i.e. a proportion of the total cross-sectional flow area in which floodwater would remain motionless, thus being temporarily retained in the floodplain (Wyżga, 1999; Czech et al., 2016). At the 2-year flood, the retention potential of floodwater increased from 0% in 2013 to 4% in 2015, while at the 50-year discharge it increased from 14% to 20%. Before the restoration works, only 1/5 of the evaluated stream cross-sections was classified as representing good hydromorphological quality, whereas after the works 4/5 of the cross-sections fell in this class of hydromorphological quality. The hydromorphological quality improvement mainly reflected changes in bed substrate, erosional and depositional channel features and longitudinal stream connectivity.

Figure 1. View of Krzczonówka Stream in the vicinity of one of study cross-sections shortly after installation of a boulder ramp (2013) and after the passage of the flood of May 2014. Visible the entrapment of a considerable amount of gravel and burying of the boulder ramp.
