## **IS THE HEADWARD EROSION A DOWNSTREAM EFFECT OF DAMMING THE COCA RIVER?**

Comment l'altération anthropique des flux hydrosédimentaires a perturbé les infrastructures stratégiques situées sur le fleuve Coca ?

Isabel Bernal<sup>1</sup>; Christian Romero<sup>2</sup>, Daissy Qhispe<sup>3</sup>

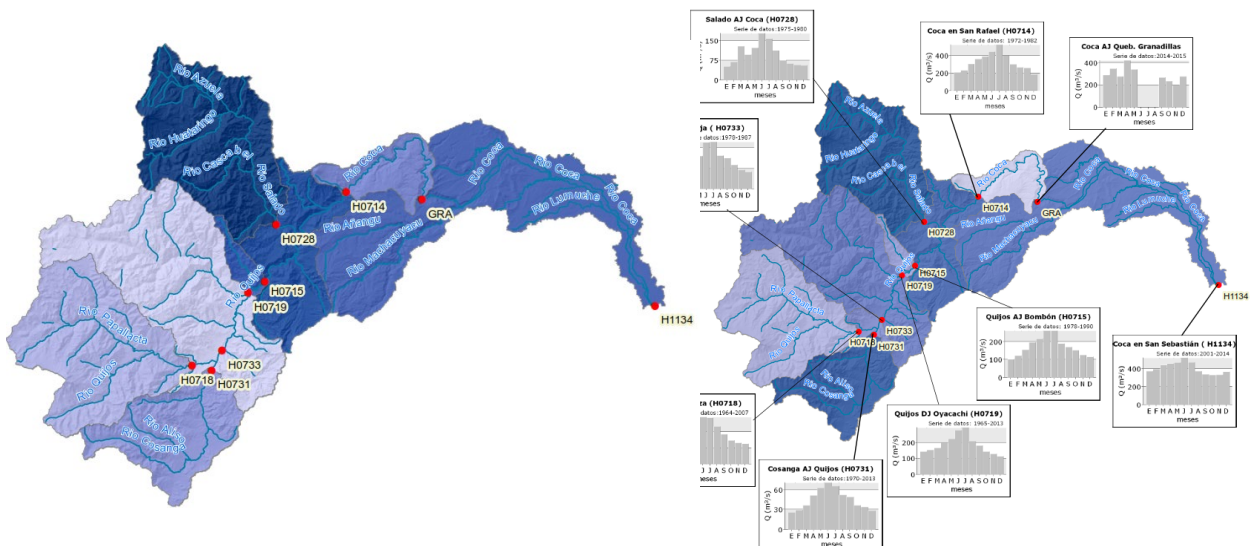
Figure 2.- Solid and Liquid Discharge in the Coca River Watershed

The CHRC is the second place more humid in the Amazonian Watershed and it has a dynamic river system, whose Salado River sub-watershed is characterized by providing the greatest contribution per square kilometer in terms of both solid flow (1,078.15 t/km<sup>2</sup> yr<sup>-1</sup>) and liquid flow (114.06 l.s-1.km<sup>-2</sup>), figure 2.

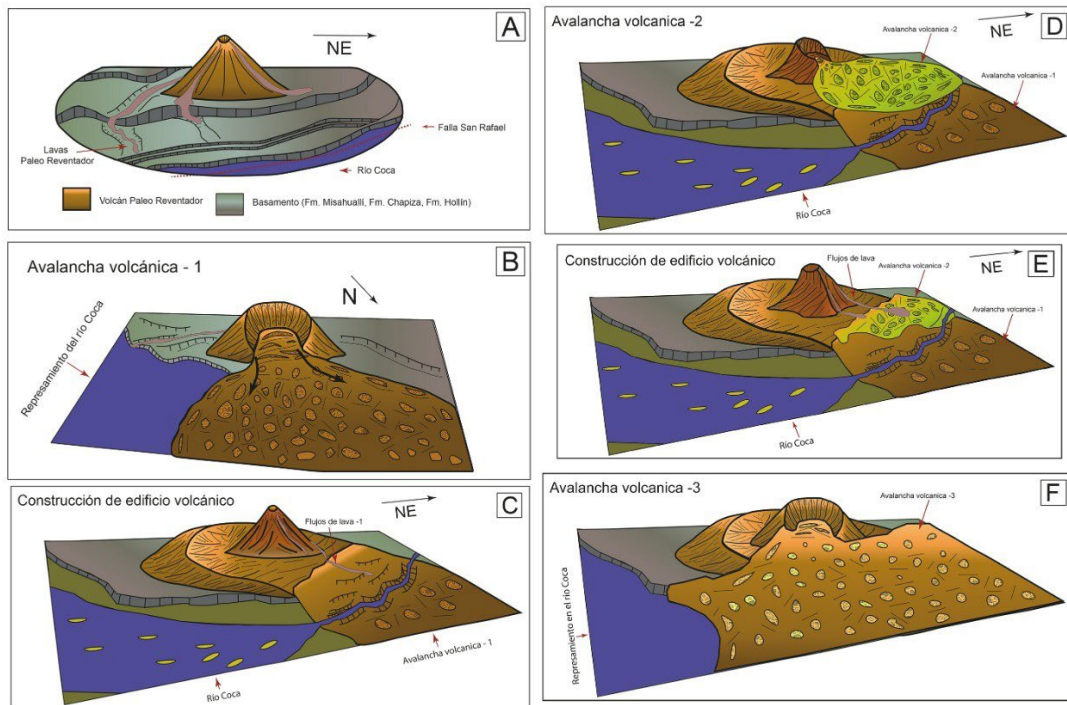
Figure 3.-Study Area Geological Model, IIGE 2020

In this zone, the lithology of the riverbed is mainly made up of volcanic deposits from the Reventador volcano (avalanche deposits) and fluvial-lacustrine deposits resulting from the close relationship between the CR and the Reventador volcano throughout its geological history. The geological model shows a natural process of HE, that was present in the CR geological history. In fact, the CR suffered periodic natural damming as a result of the geodynamic activity of the area (earthquake and volcano) and the river responded with erosive processes in order to release its enormous flow, figure 3.

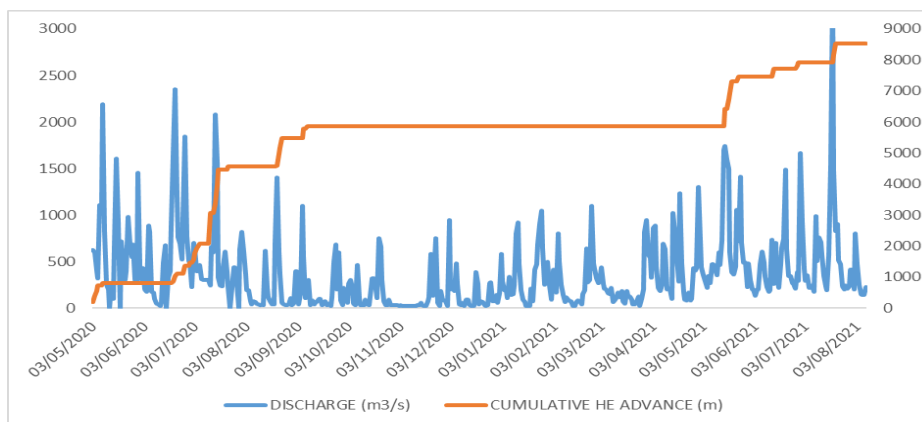
Figure 5.- Erosion Advance vs. Discharge

The erosion rate has not been permanent or sustained, as the peak discharge during the rainy season and the riverbed lithology have accelerated or slowed the advance of erosion, figure 5. The erosive front has been temporarily stopped twice during the dry season but has continued to erode the banks of the Coca river and influence the erosion of tributaries such as the Montana, Marker and Malo rivers. Since its beginnings, the regressive erosion has marked the evolution of the river profile in the form of a slide that loses slope as it moves away from the old waterfall, figure 6.
