## **Monitoring of a sediment replenishment operation: The case of the Saint-Sauveur dam in the Buëch River (Southern Alps, France)**

Guillaume Brousse<sup>1</sup> ; Mélanie Bertrand<sup>2</sup> ; Gilles Arnaud-  
Fassetta<sup>1</sup> ; Frédéric Liébault<sup>2</sup> ; Laurent Borgniet<sup>3</sup> ; Gabriel Melun<sup>4</sup> ;  
Remi Loire<sup>5</sup> ; Jean-René Malavoï<sup>5</sup> ; Guillaume Fantino<sup>6</sup>

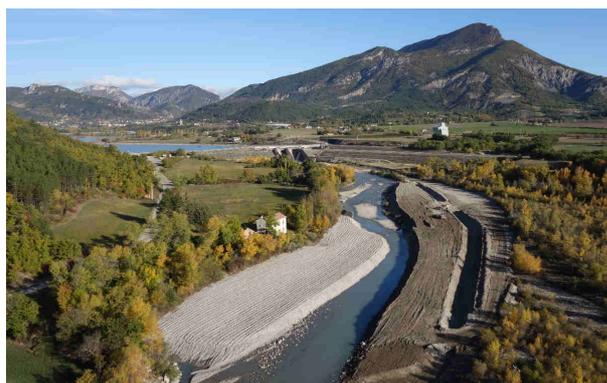
Figure 1 : The replenishment site at the end of the restoration (source: EDF).

deposited along a 400 m reach downstream from the dam, by the creation of two artificial gravel berms according to “point bar stockpile method” (Ock et al., 2013; fig.1). To facilitate the remobilization of the left-side berm, a trench was cut into the deposit. In addition, new rules of hydraulic transparency are established in order to increase sediment input in the restored reach. The general objective of the restoration project is to improve the hydromorphological conditions of the degraded reach downstream from the dam. A complementary objective is to reduce the flooding risk upstream from the dam.

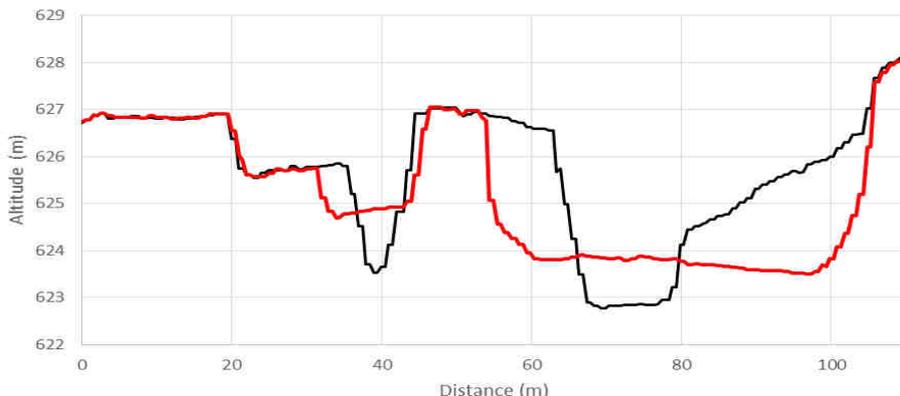
Figure 2: Eroded cross section after Q<sub>10</sub> flood.

This graph is obtained by DEM differencing (after restoration in black and after flood in red). See the right and central erosion of artificial berms. Left berm was not really eroded because of not flooded surface and low energy in the trench.

(6100 m<sup>3</sup>) and on the central berm (13,000 m<sup>3</sup>) but very low on the left berm (1100 m<sup>3</sup>, fig.2). The trench has been strongly shortened (380 m to 198 m). Its relative elevation from the main channel increased and its slope decreased from 0.54 to 0.2%.
