Erosion of reservoir sediment from the removal of two large dams on the Elwha river, Washington, USA

Timothy J. Randle, Jennifer A. Bountry, Andrew Ritchie

U.S. Department of the Interior, Bureau of Reclamation and National Park Service

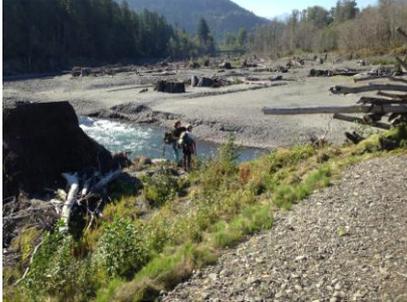
Figure 1. Photograph looking upstream along the former Lake Aldwell delta.

After phased dam removal, the reservoir landscape consists of a series of sediment terraces of varying heights composed of prograded coarse sediment overlying fine lakebed deposits (Fig. 1 and 2) (Randle et al., 2014). The predam surface is exposed along the river corridor, and abundant 1 to 3 m stumps from pre-removal forests create unique morphology where the river interacts with the predam landscape.

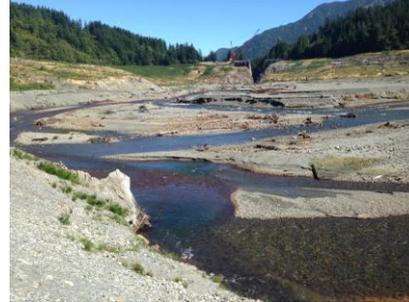
Figure 2. Photograph looking downstream along the former Lake Mills toward Glines Canyon Dam site.
